# PUBLIC ROADS

A JOURNAL OF HIGHWAY RESEARCH

VOL. 20, NO. 11

Page
Experiments With Continuous Reinforcement in Concrete Pavements . . . . .	205
The Cost of Curing Concrete Pavements With Cotton Mats . . . . .	215
Cost of Operating Rural-Mail-Carrier Motor Vehicles . . . . .	217

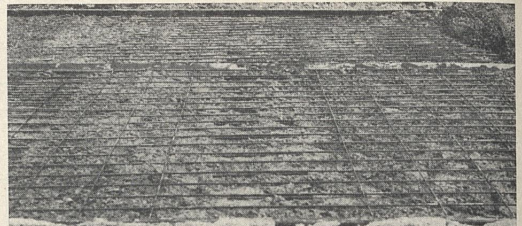
FIGURE 11.—SHEAR DOWEL BARS IN PLACE AT LOCATION WHERE WEAKENED-PLANE JOINT IS TO BE FORMED.

Figure 11 shows the bars in place at one of these joints before placing the top part of the concrete. This method of supporting dowel bars is not recommended for use at joints where longitudinal movements of appreciable magnitude are expected, because of the possibility that some misalignment may develop during the placing of the concrete. In this instance, however, with the 10-foot joint spacing and with longitudinal steel placed continuously through the joints, the longitudinal movements at any one joint should be quite small and with the close supervision given all construction operations it was thought the method of installation would be satisfactory.

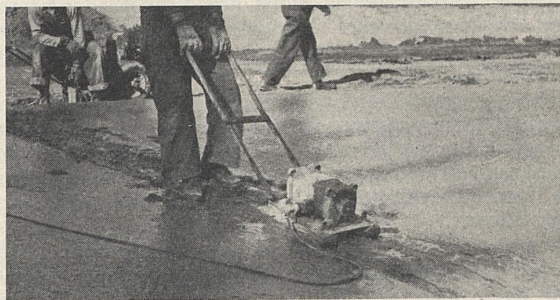
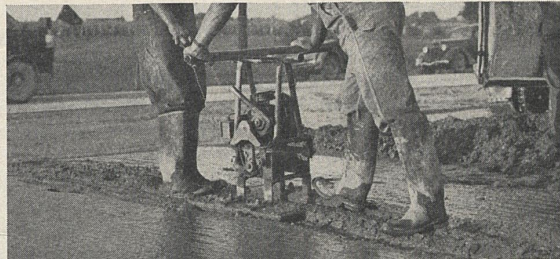
FIGURE 15.—VIBRATORS USED AROUND TYPE III JOINTS. UPPER, VIBRATOR USED ON EAST PROJECT; LOWER, VIBRATOR USED ON WEST PROJECT.

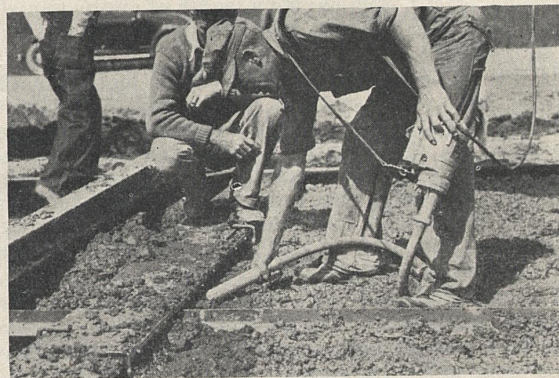
FIGURE 16.—INTERNAL VIBRATOR USED UNDER TYPES I AND II JOINTS.

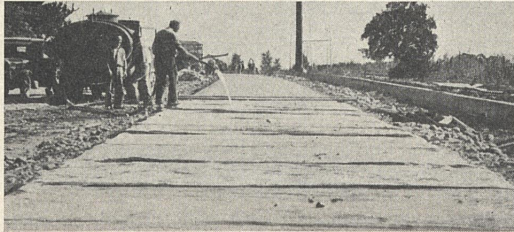
FIGURE 1.—COTTON MATS IN PLACE BEING WET DOWN.

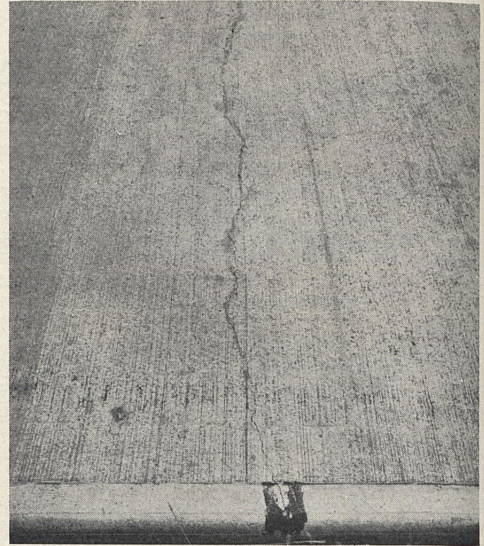
FIGURE 20.—TYPICAL CRACK IN A HEAVILY REINFORCED SECTION.
